# **WATER DAMAGE ASSESSMENT**

**Lillian M. Jacobs Elementary School  
180 Harborview Road  
Hull, Massachusetts**

Prepared by:  
Massachusetts Department of Public Health  
Bureau of Environmental Health  
Indoor Air Quality Program  
February 2018

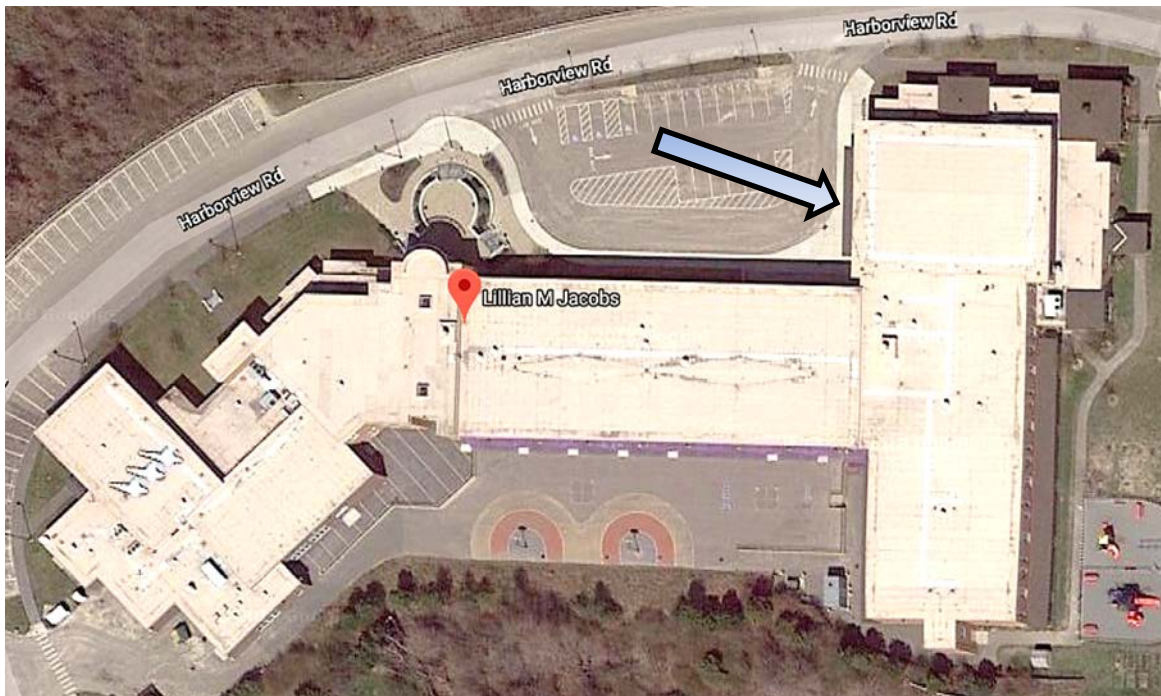
**Picture 1**

This assessment was prompted by concerns focused on water penetration in the gym. The assessment occurred on a Monday morning after a Sunday of steady rain (reportedly heavy at times). At the time of assessment, water was noted dripping from the ceiling along the west wall (Pictures 1 through 3) and collecting into a small puddle on the gym floor (Picture 4). In addition, building occupants reported that water has penetrated the ceiling near the air handling unit during heavy rain/wind events (Picture 5). No water was observed under the gym air handling unit on the day of the assessment.

**Area of gym (arrow) where active leak was observed**

1. Continue with plans to obtain a certified roofing contractor to evaluate and make repairs to prevent further leaks.
2. In the interim, monitor for continued leaks and catch in containers (e.g., buckets/mop) to prevent damage to the floor. Avoid storing porous materials such as furniture or paper in these areas.
3. Post “hazard/wet floor” signs as needed, to prevent injury to occupants/staff.
4. For more information about mold consult the US EPA’s “Mold Remediation in Schools and Commercial Buildings” published by the US Environmental Protection Agency (US EPA, 2008) (<https://www.epa.gov/mold/mold-remediation-schools-and-commercial-buildings-guide>)
5. Refer to resource manual and other related IAQ documents located on the MDPH’s website for further building-wide evaluations and advice on maintaining public buildings. These documents are available at: <http://mass.gov/dph/iaq>.

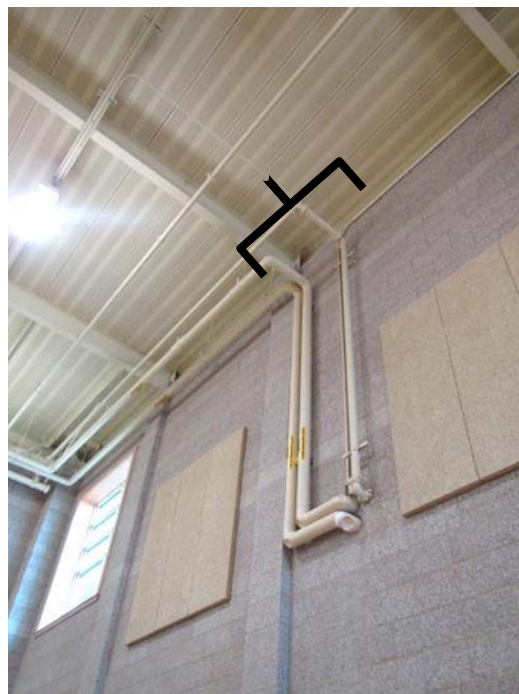
**Picture 2**

**Bracket indicates area of leaks inside gym**

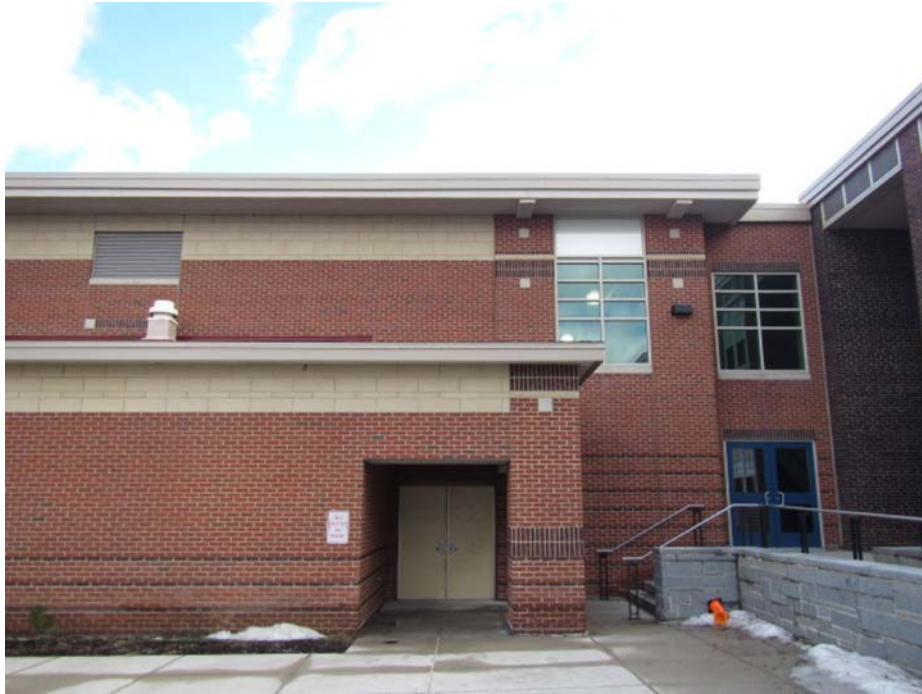
**Picture 3**

**Exterior view of leaking area of gym**

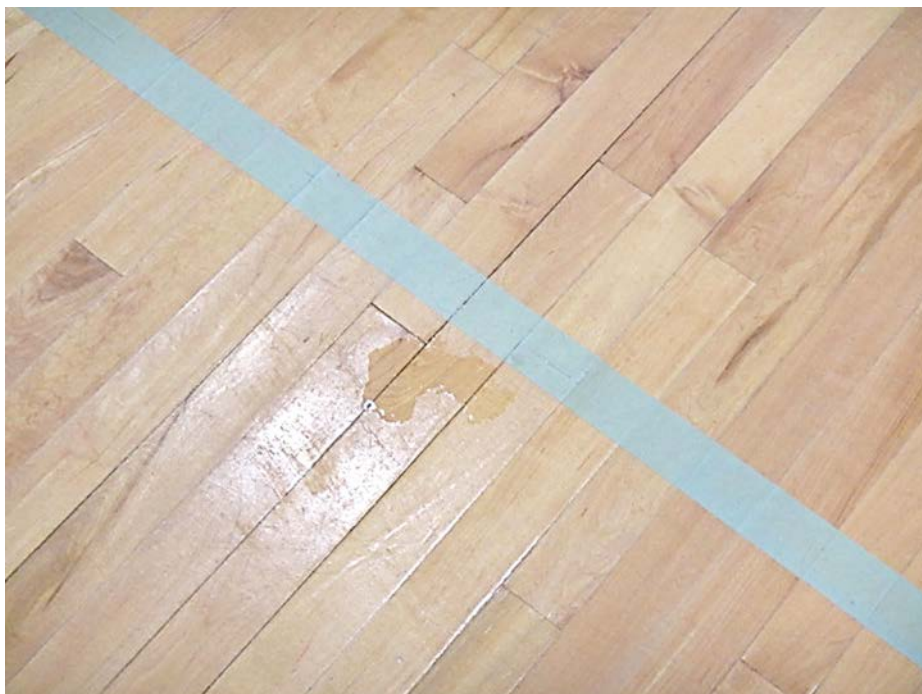
**Picture 4**

No porous building materials (e.g., carpet, ceiling tiles, gypsum drywall) are located in areas of puddling water. The water impacted materials are wooden floor (semi-porous), metal

**Puddling of water in gym after rain event**

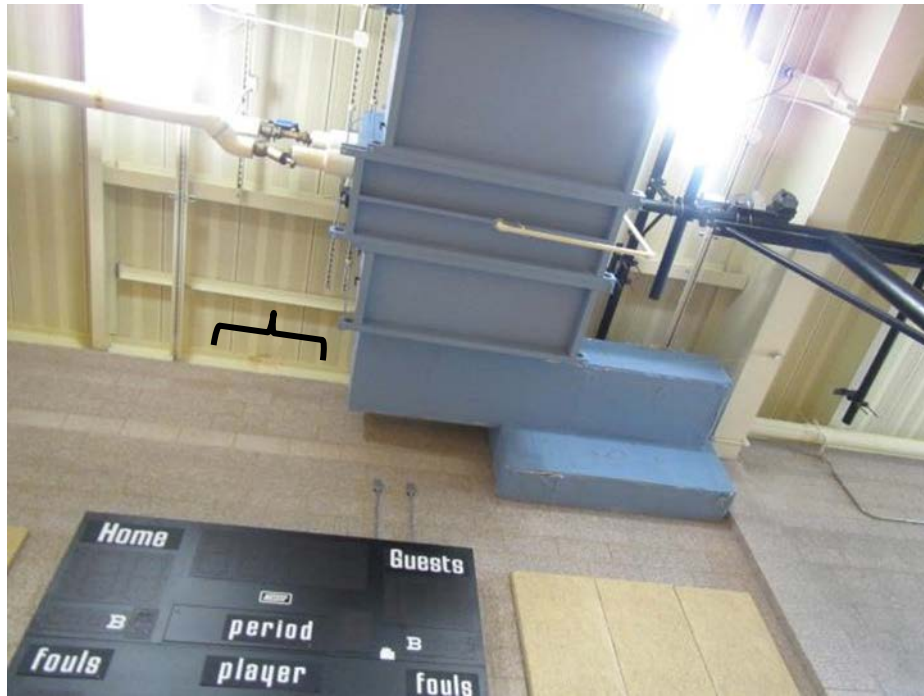
**Picture 5**

**Area of ceiling (bracket) near air handling unit, where leaks reportedly occur**
